RAISING EFFICIENCY IN PHOTOVOLTAIC SYSTEMS: HIGH RESOLUTION MONITORING AND PERFORMANCE ANALYSIS

S. K. FIRTH

The Institute of Energy and Sustainable Development
De Montfort University

A thesis submitted in partial fulfilment of the requirements of
De Montfort University for the degree of Doctor of Philosophy

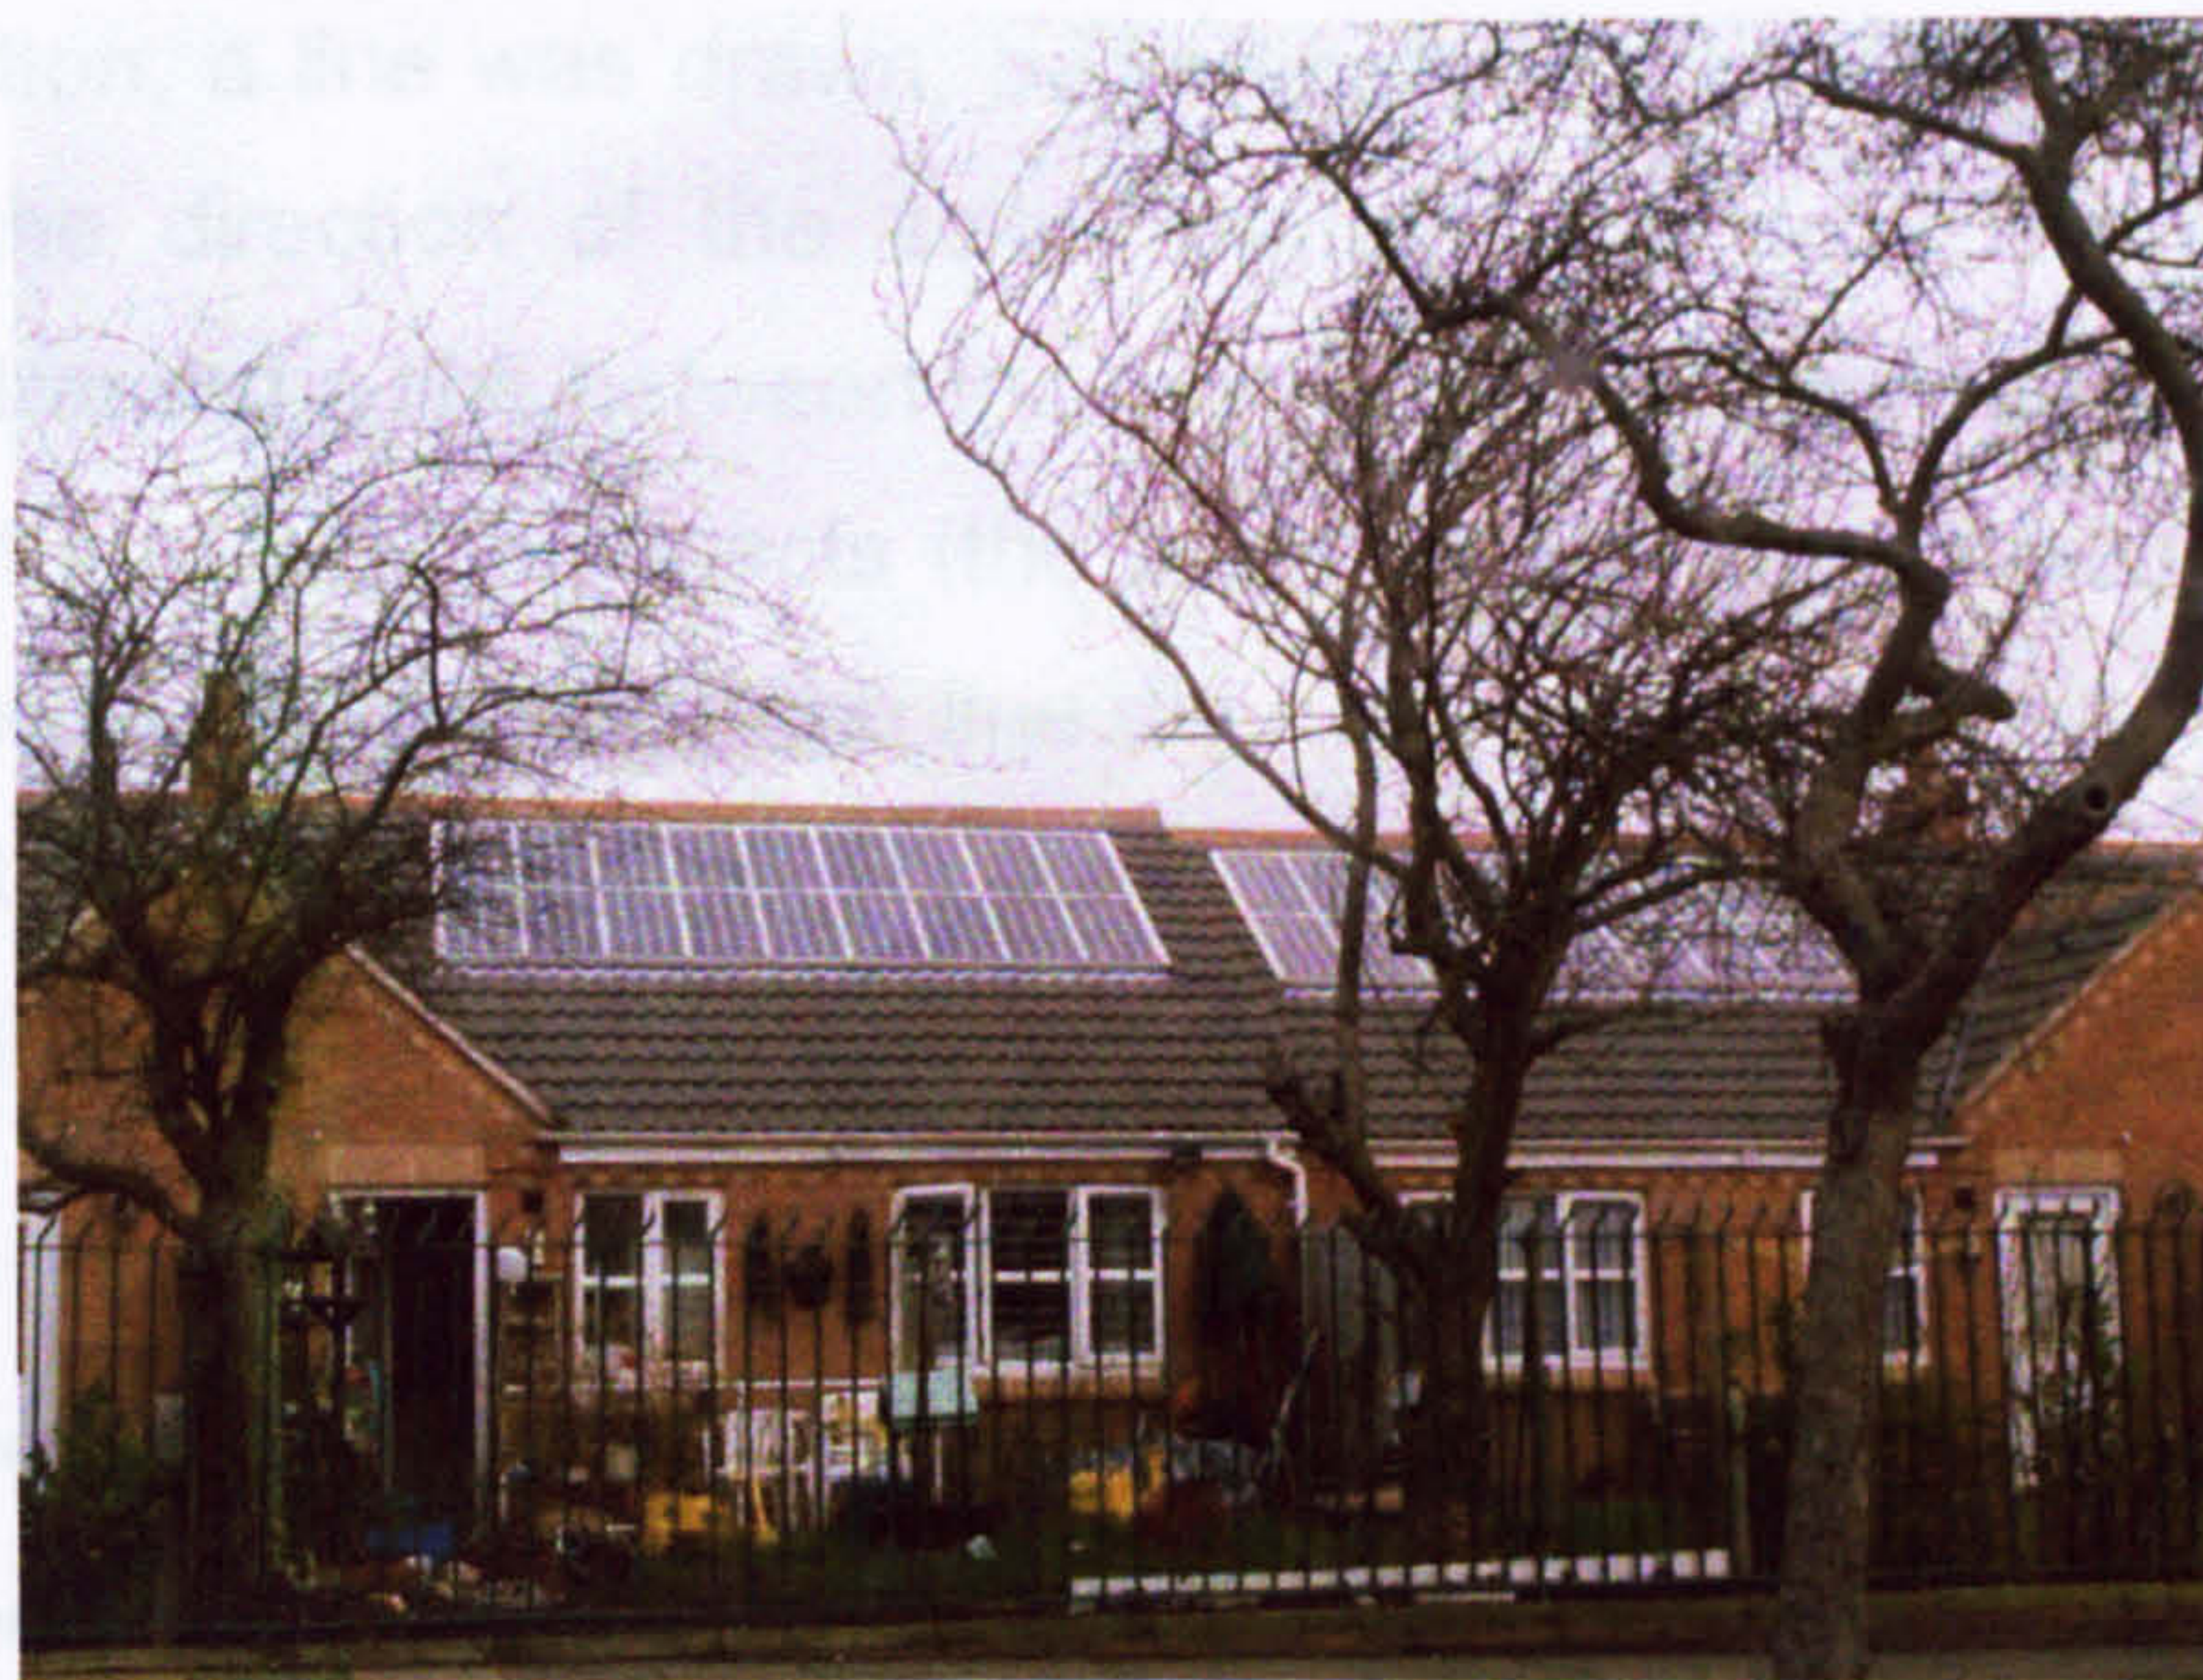
Figure 7-8: Systems 4 and 5 at Corncroft (system 5 is the PV array on the left). The large tree to the south is the middle tree in the photograph. The west porch roof is to the left of the PV array in the photograph and the other surrounding trees can be seen.

At Corncroft, CC 5 was chosen to be modelled and a site visit was made to the site to study the site geometry. There were several external shading objects: a large tree to the south of the PV array; smaller trees from south east to south west; and a porch roof to the west (Figure 7-8). Using measurements of the site geometry, the PV array and surrounding objects were recreated as a three dimensional model (Figure 7-9).
